SUBJ: RCRA Compliance Evaluation Inspection  
EPA ID # - GAD 093 380 814

## RCRA Inspection Report

Perma-Fix of South Georgia, Inc. (PFSG)  
Azalea Industrial Park  
1612 James P. Rogers Circle  
Valdosta, Georgia 31601

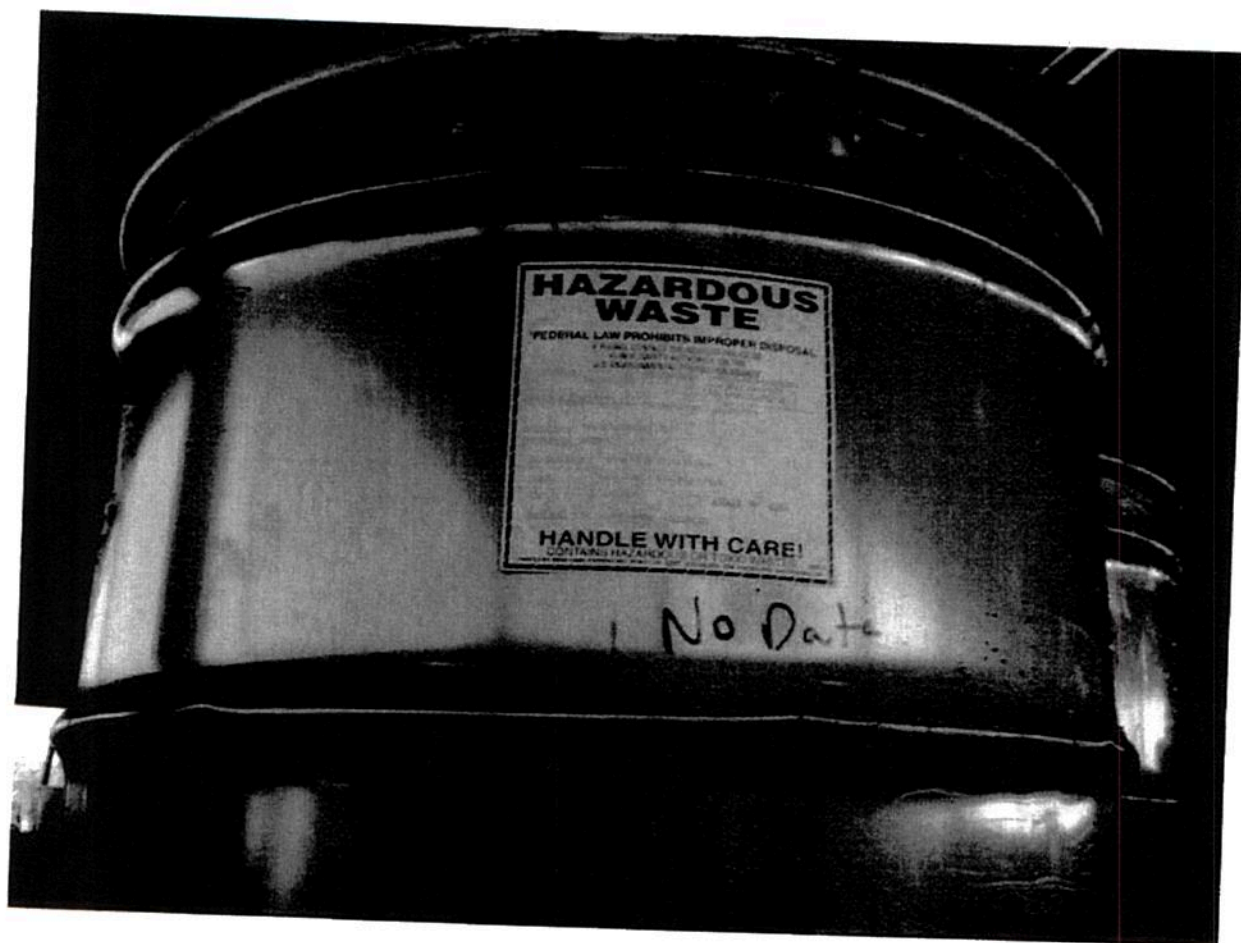
One 55 gallon over-pack drum located on the west side of Row I (drum identification code - DV14516-2) was not marked with an accumulation start date (Photo 1). **PFSG appeared to be in violation of Permit Condition II.B.11 of Permit No. HW-0020(S&T) by accumulating hazardous waste in a container which was not clearly marked with the date which the accumulation began.**

Photo 1 – Drum w/o accumulation start date on the west side of Row 1 Drum ID Number (DV14516-2)

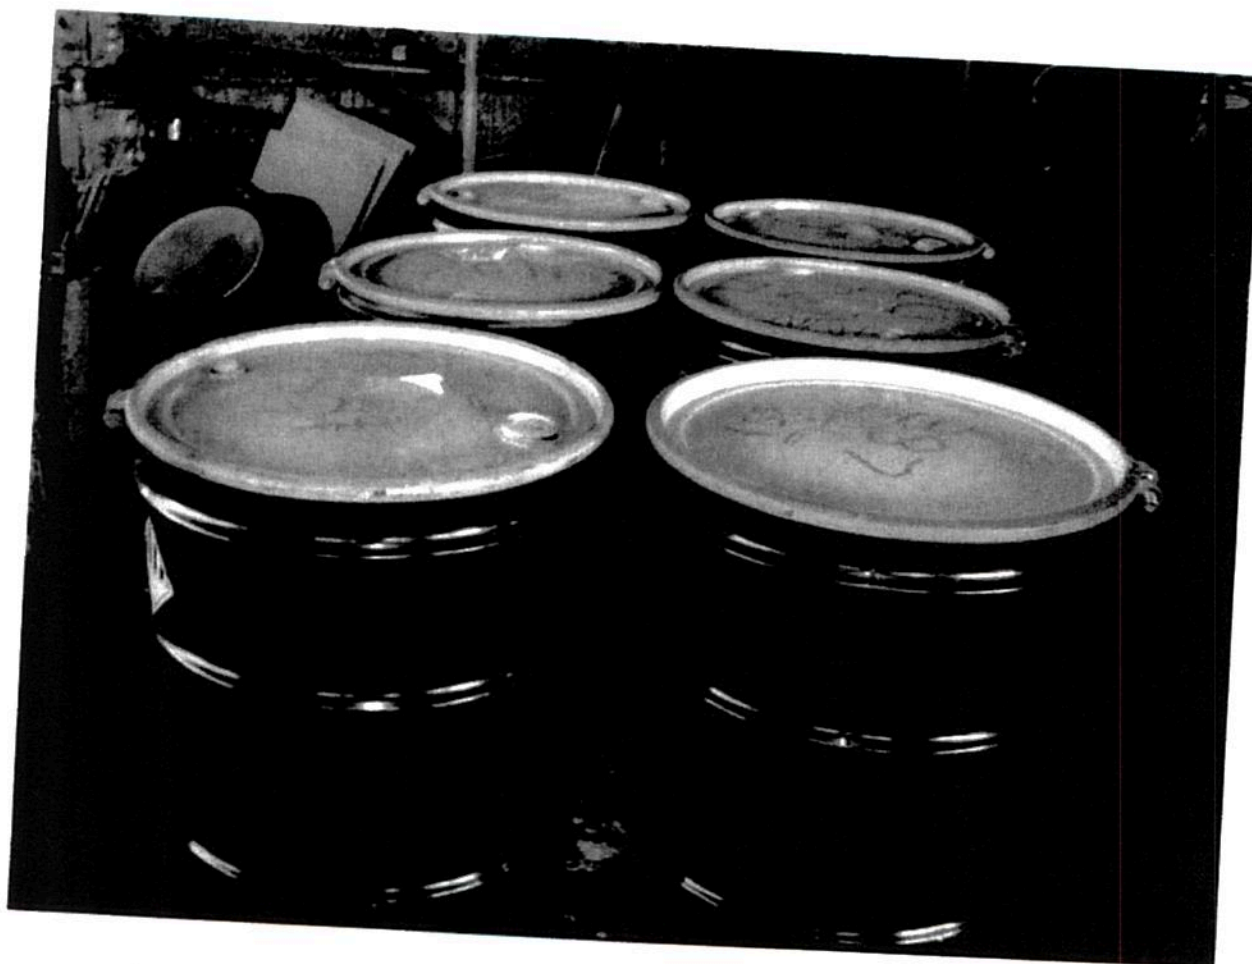
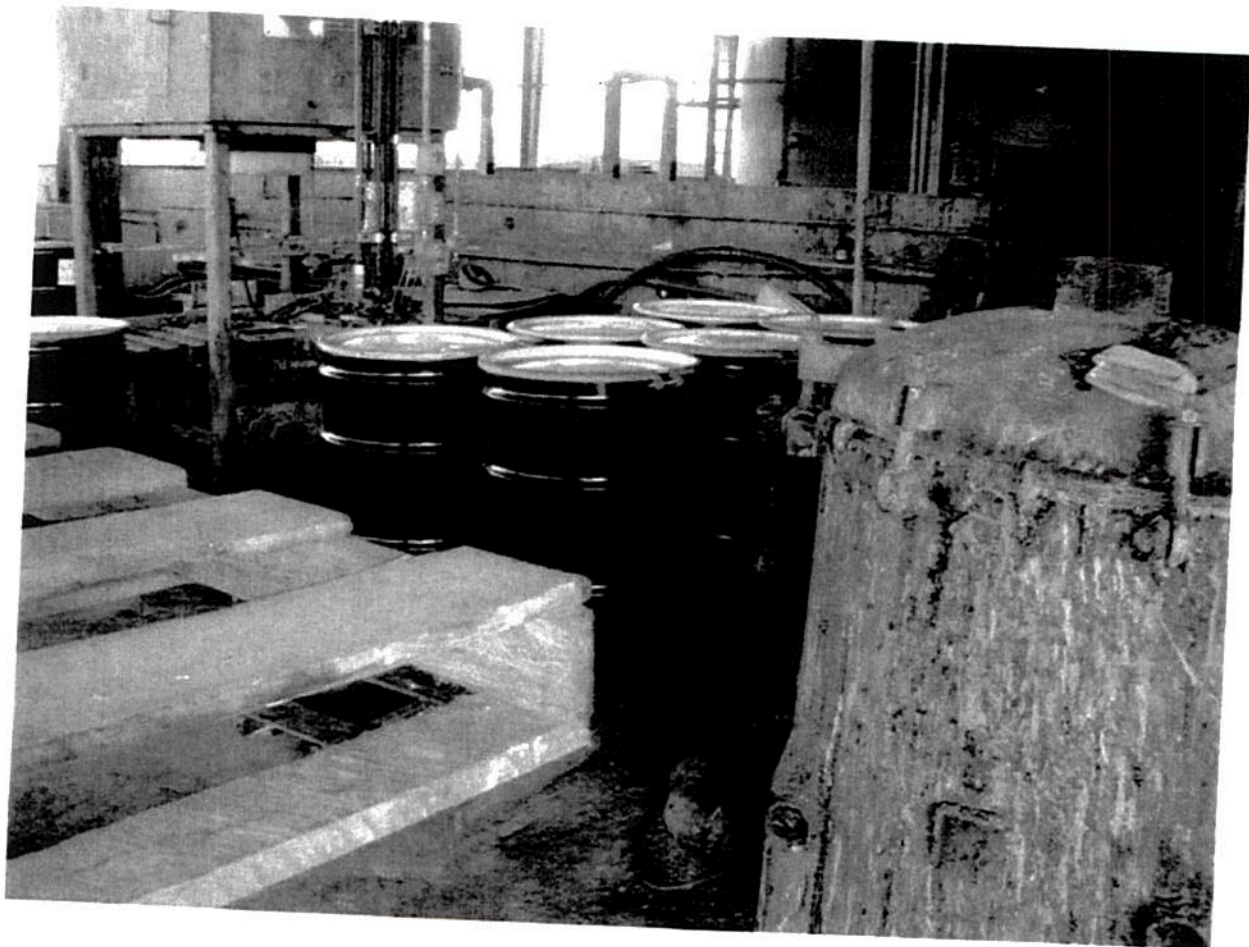
Four 55-gallon drums (Photos 2 & 3) were observed in Row I-10 without "Hazardous Waste" labels or accumulation start dates. **PFSG appeared to be in violation of Permit Condition II.B.11 of Permit No. HW-0020(S&T) by accumulating hazardous waste in containers which were not clearly marked with the date which the accumulation began or with the words "Hazardous Waste."**

Photo 2 – Four drums w/o accumulation start date or labels in Row I-10

Photo 3 – Four drums w/o accumulation start date or labels in Row I-10

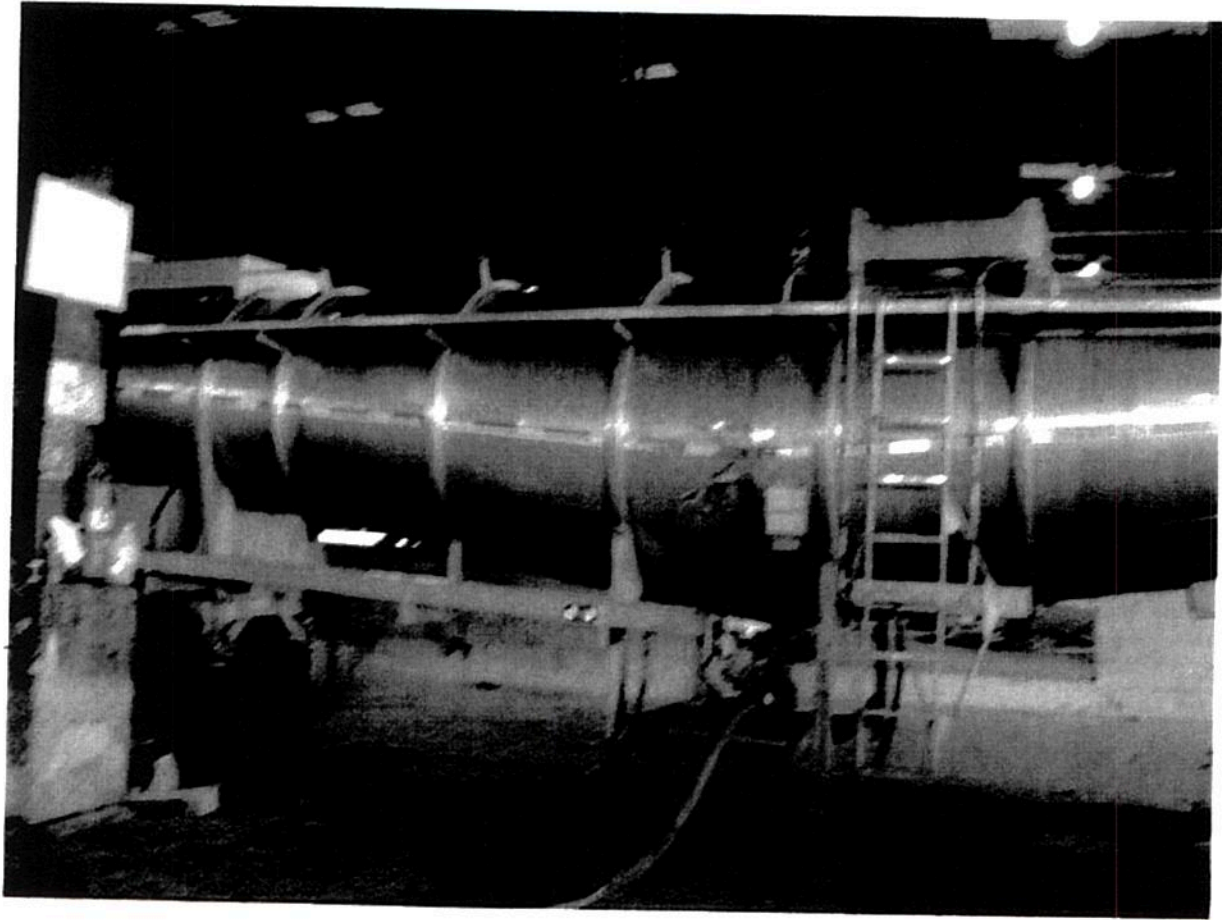
At the time of the inspection, one 6000 gallon tanker holding approximately 2000 gallons of hazardous waste flammable liquids (D001) was observed in this area. The tanker was not labeled with the words "Hazardous Waste" or marked with an accumulation start date. **PFSG appeared to be in violation of Permit Condition II.B.11 of Permit No. HW-0020(S&T) by accumulating hazardous waste in containers which were not clearly marked with the date which the accumulation began.** In addition, the tanker was not grounded. (Note: GA EPD's CEI report will include a violation for the facility's failure to ground this tank as required by the facility's permit application.

Photo 5 – Tanker truck located in Waste Bulking and Unloading Area

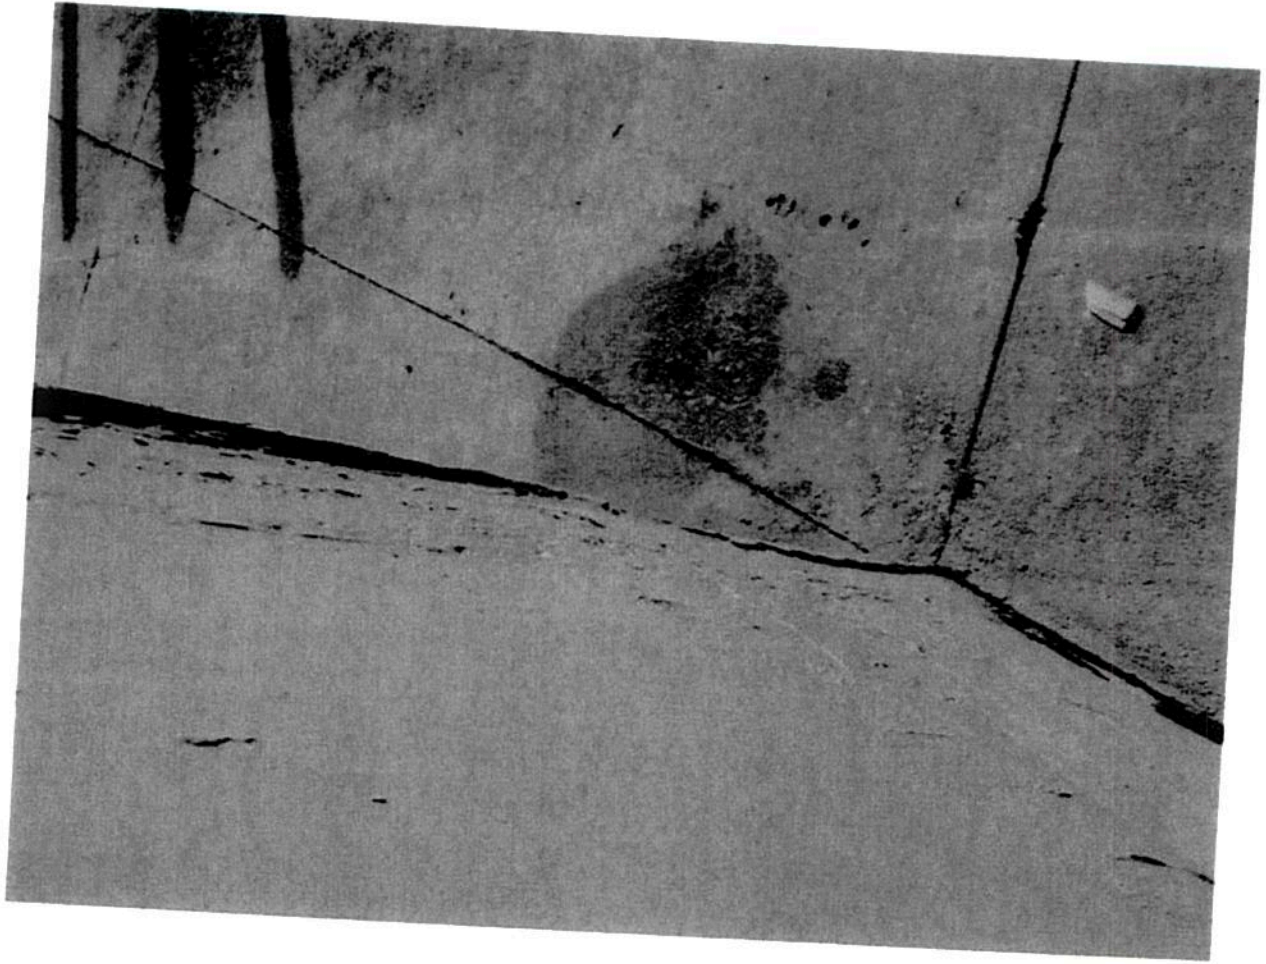
A crack in the south concrete containment wall (Photo 6), which was not addressed with sealant, and cracked and missing floor coating (Photo 7&8) were observed in this area. (Note: other locations of cracks or missing coating will also be documented in a GA EPD's CEI report) **PFSG appeared to be in violation of Permit Condition II.B.12 of**

Photo 6 – Cracks observed in the south containment wall of the Drum Processing Area

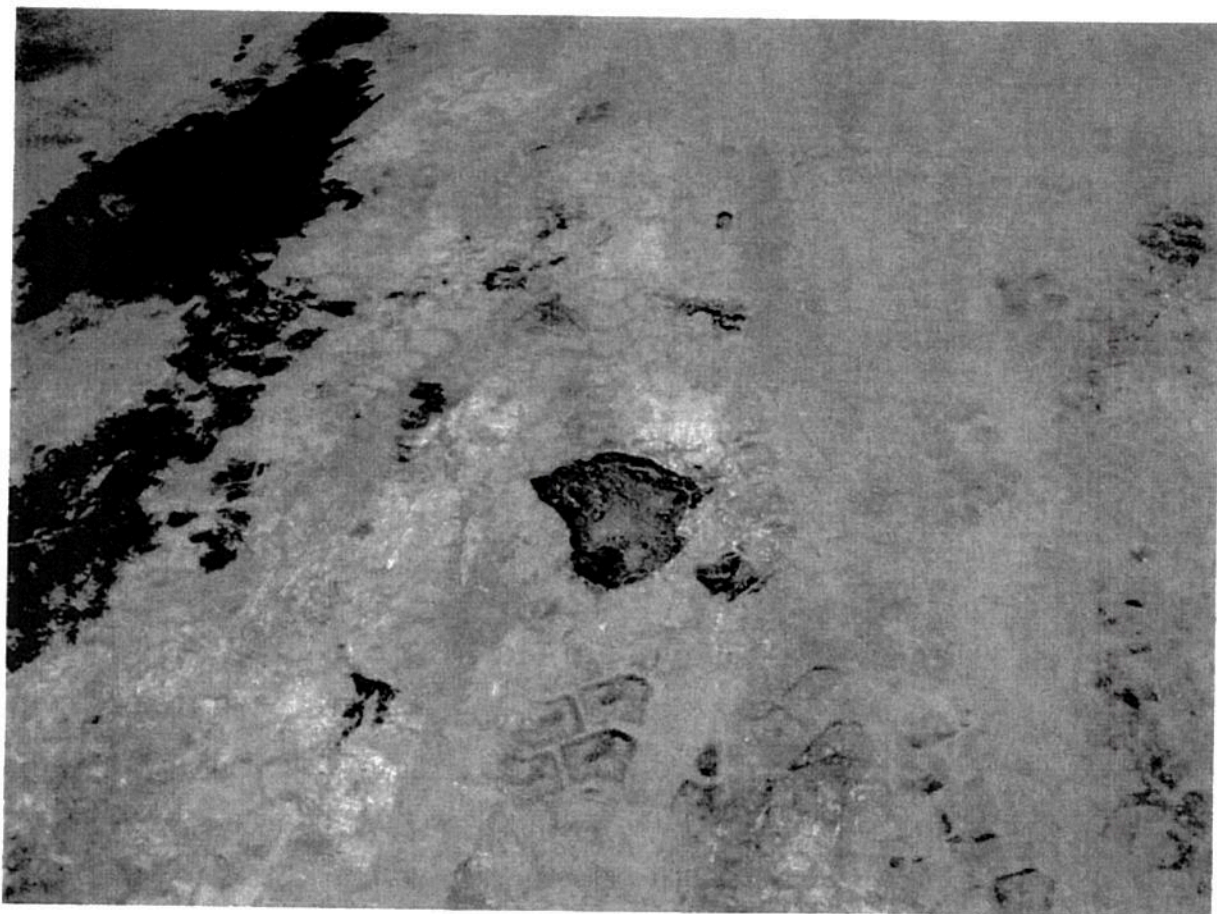
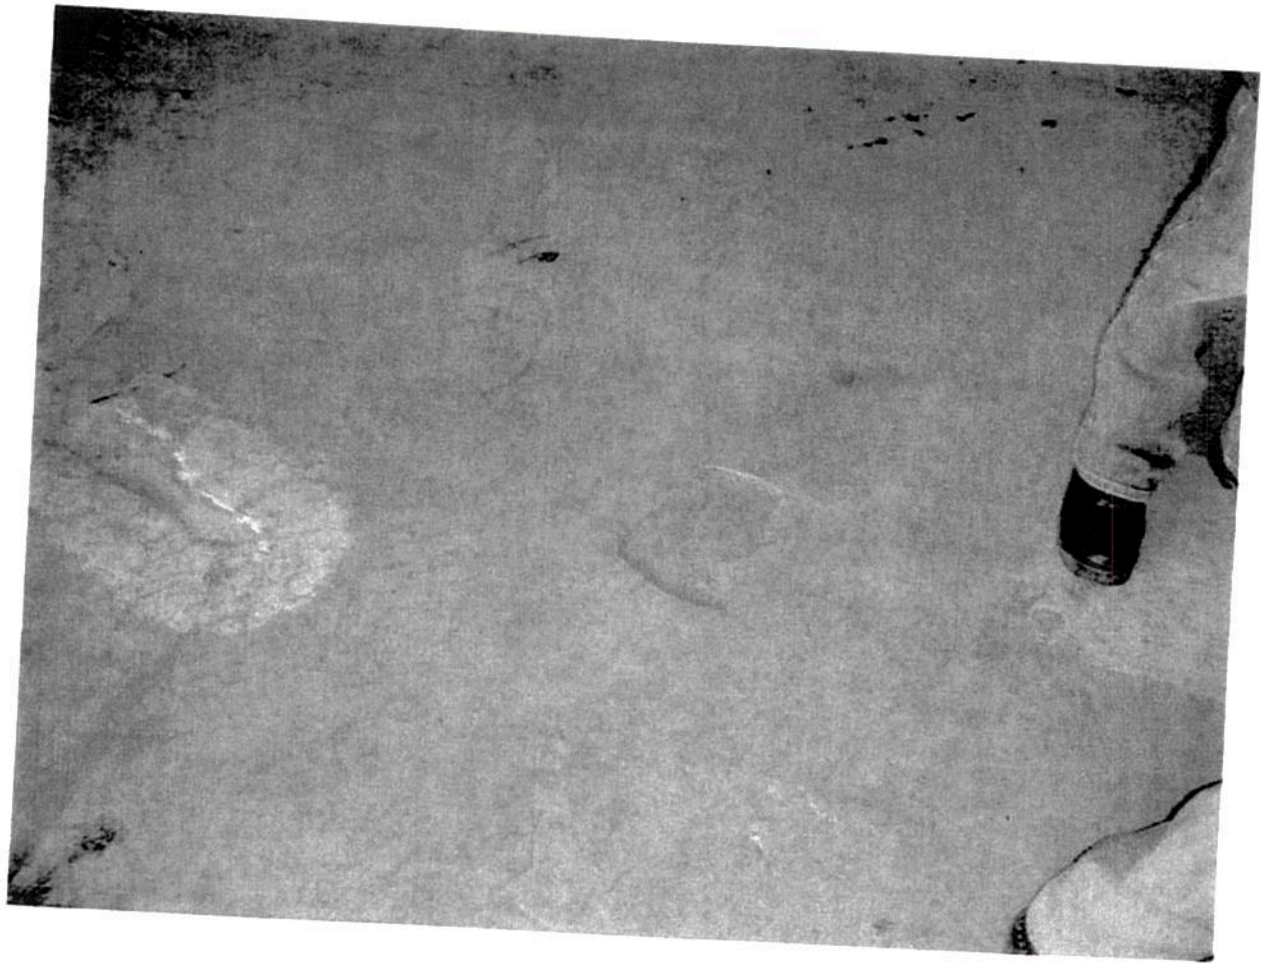
Photo 7 – Coating missing from the floor of the Drum Processing Area

Photo 8 – Coating missing from the floor of the Drum Processing Area

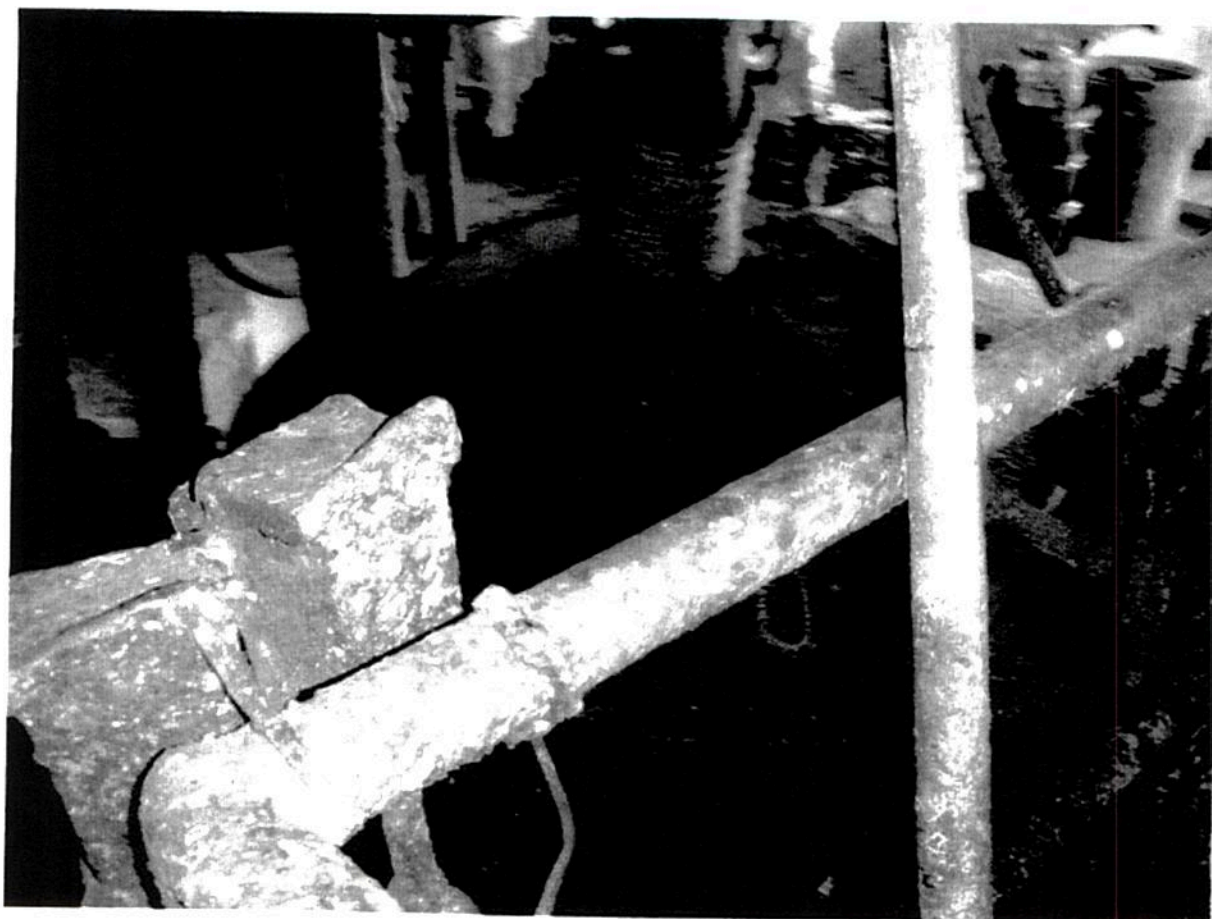
1/4/2012 – A fire occurred in Tank F-3. The fire was put out by facility personnel without the assistance of fire department personnel.

Photo 11 – Cover missing on F-3 Tank

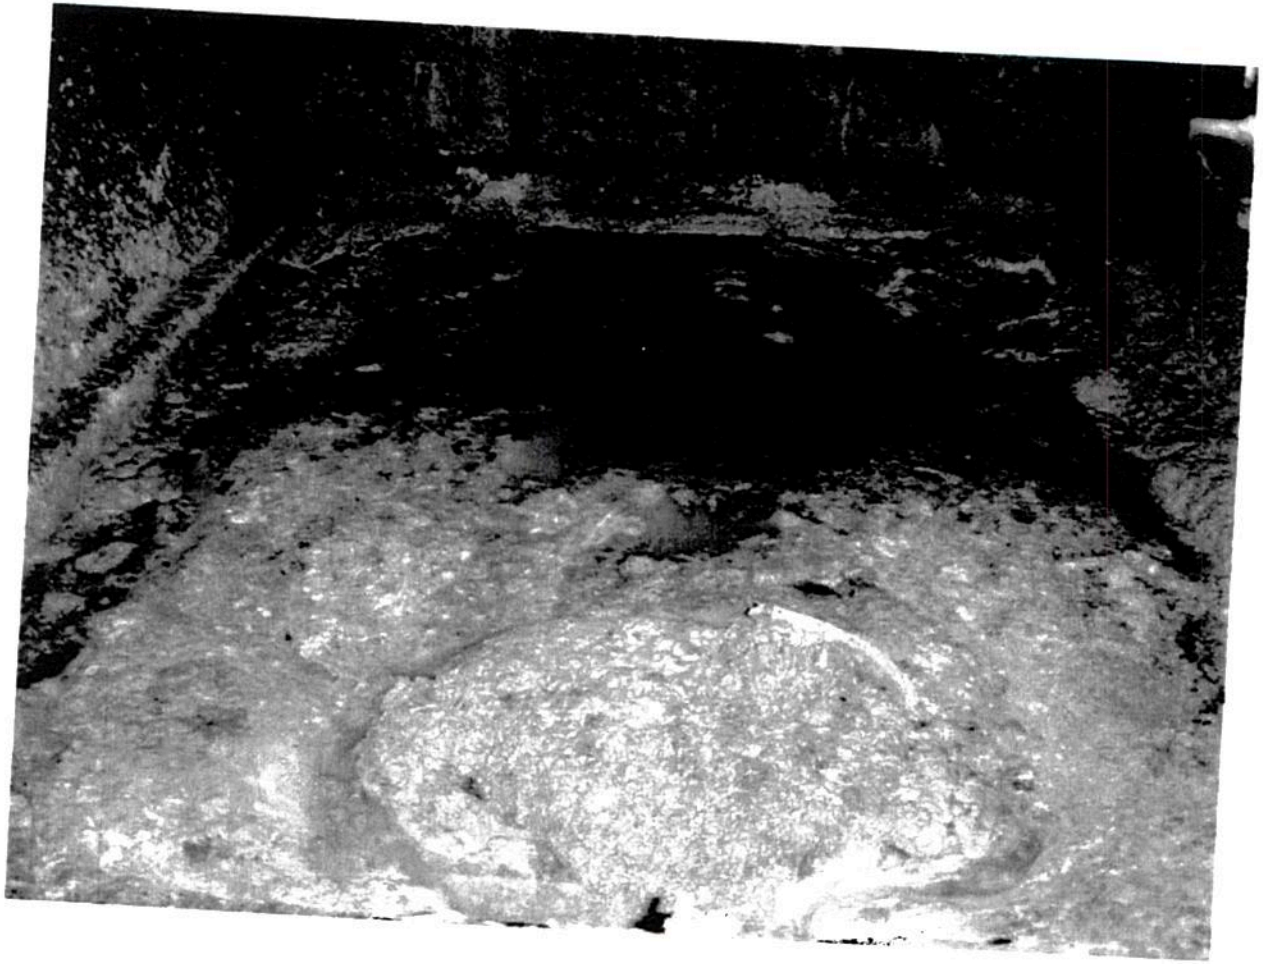
Photo 12 – Material remaining in reception bin of Tank F-3.

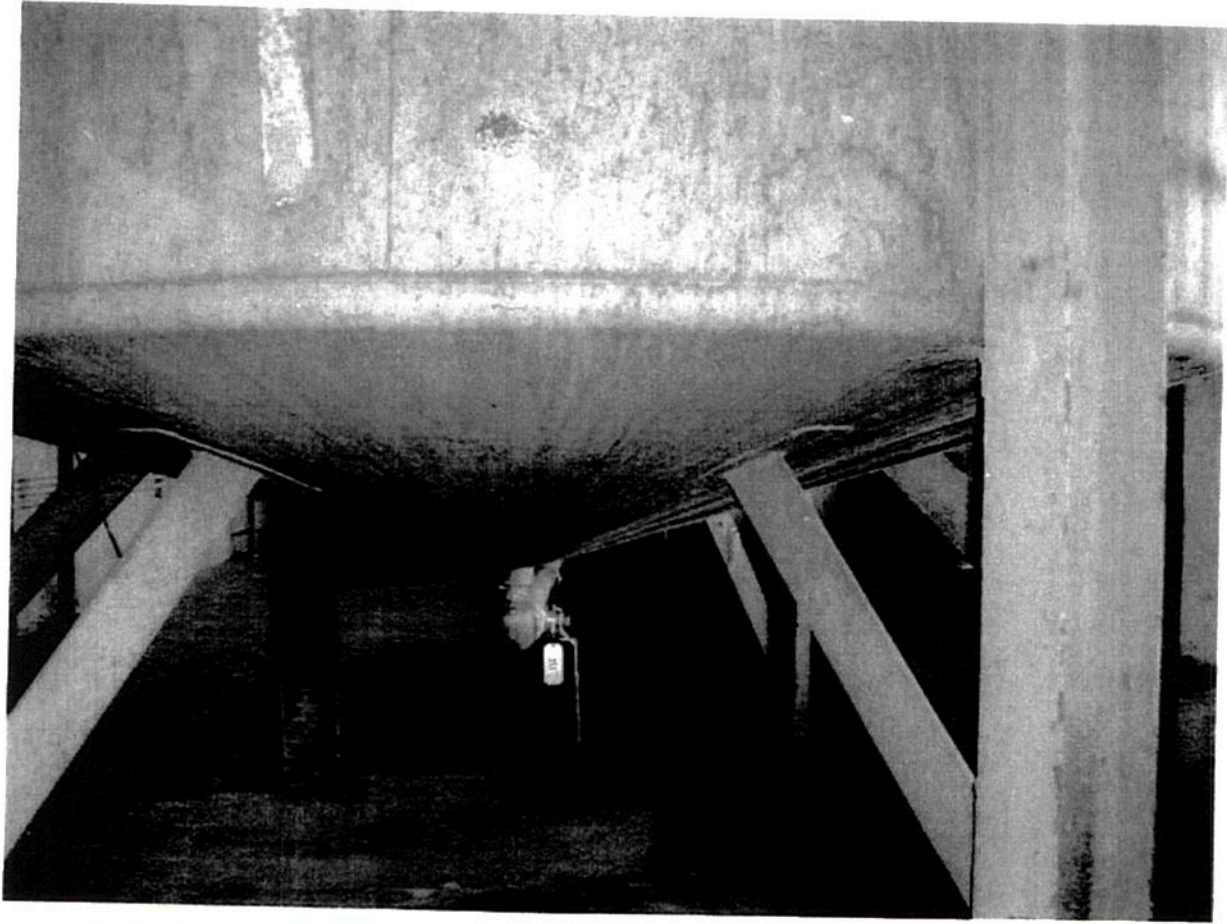
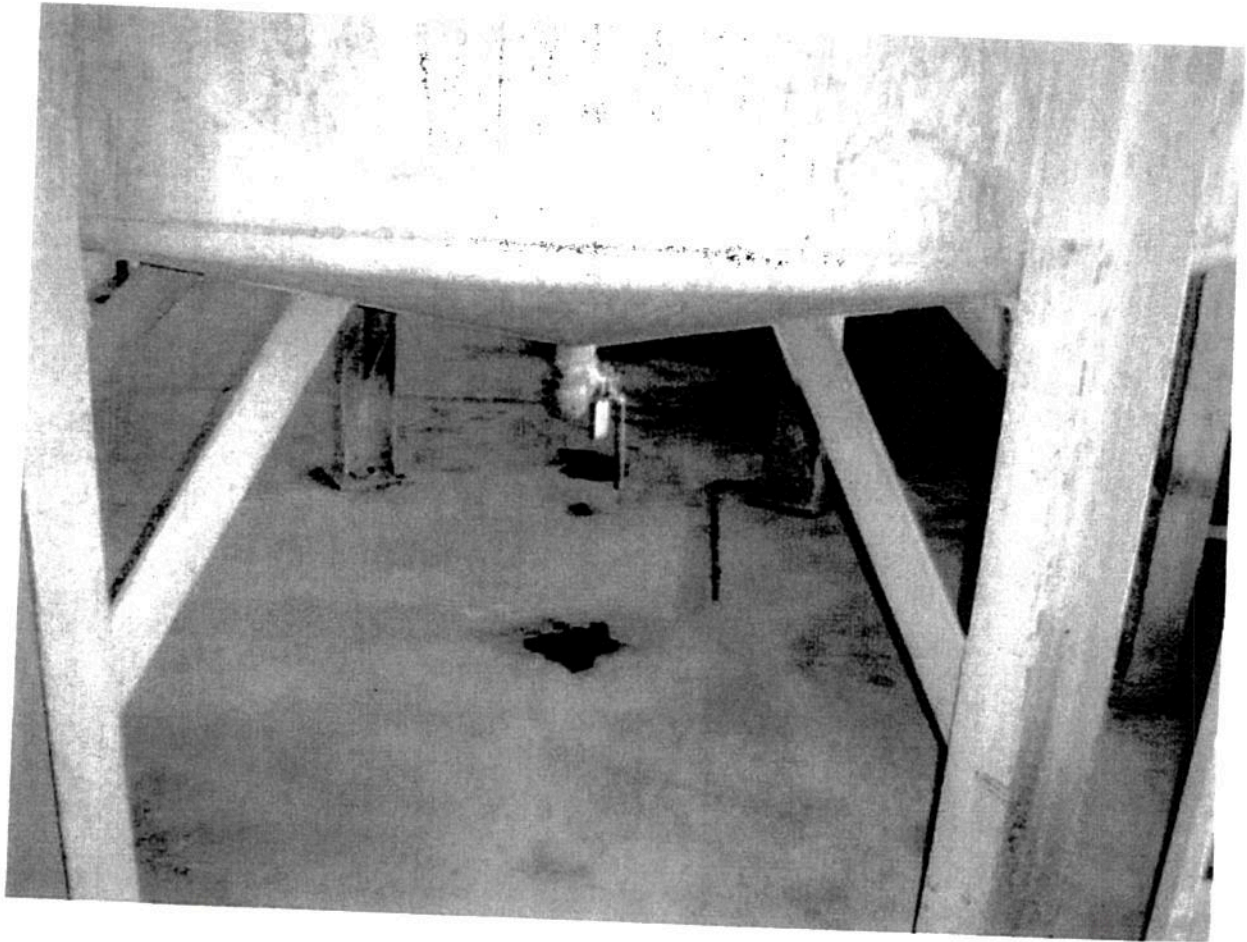
During an inspection of tanks T210, T208, and T42, two leaking pipe fittings were observed on pipes connected to and beneath tank T42 (Photos 13 & 14). The slowly leaking material was falling onto the unit's concrete secondary containment system. **PFSG appeared to be in violation of Permit Condition IV.D. of Permit No. HW-0020(S&T) by placing hazardous waste in a tank system which is leaking and is not in compliance with the applicable regulations of 40 C.F.R. Part 264 Subparts BB and CC.**

Photo 13 –Liquid hazardous waste leaking from ancillary equipment of Tank Four drum w/o accumulation start date or labels in Row I-10

Photo 14 – Liquid hazardous waste leaking from ancillary equipment of Tank Four drum w/o accumulation start date or labels in Row I-10.
